NASA Technical Memorandum 103620

# Tensile Deformation Damage in SiC Reinforced Ti-15V-3Cr-3Al-3Sn

Bradley A. Lerch and James F. Saltsman  
*Lewis Research Center*  
*Cleveland, Ohio*

April 1991

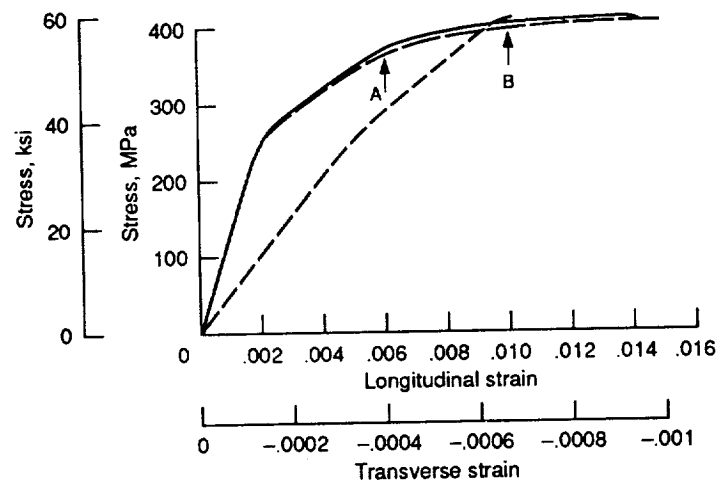
Metallographic investigations of the specimen interrupted at point A (fig. 7(b)) show debonded interfaces in the interior of the specimen. The debonding results in a linear region which has been denoted in this report as  $E_g$ . At the point of debonding, the input data to AGLPLY were adjusted to simulate the interfacial debonding by reducing the fiber modulus to 13 GPa which is 3 percent of its original value. The reduced modulus,  $E_g$ , was obtained by fitting the stress-longitudinal strain test data for the  $[90^\circ]_g$  orientation. This same fiber modulus was used for all other orientations when debonding was suspected.

(b) For a  $[90^\circ]_8$  specimen. Points A and B refer to tests that were interrupted at 0.6 and 1.0 percent strain, respectively.

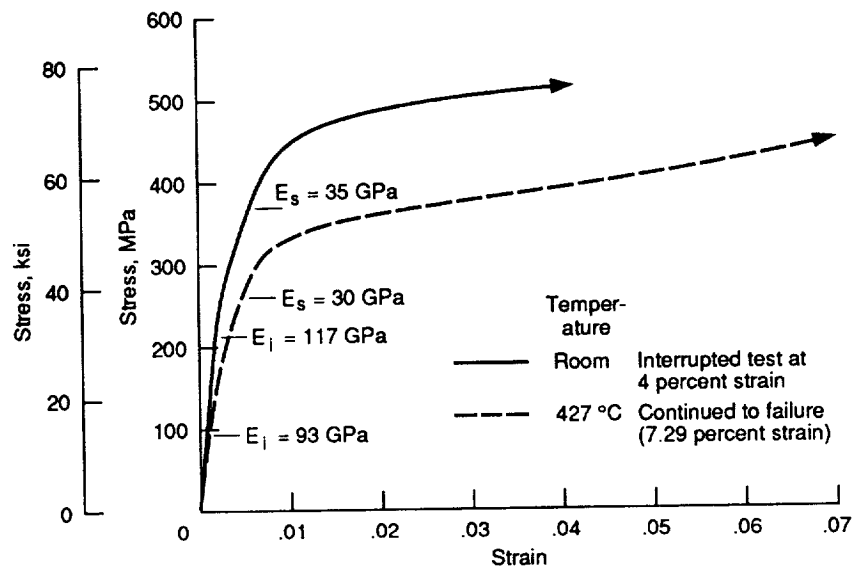
Of the layups tested at both room temperature and 427 °C, only the  $[\pm 45^\circ]_{2s}$  (fig. 10) and  $[\pm 60^\circ]_{2s}$  had significantly different stress-strain curves. At 427 °C these layups had lower moduli. Although these moduli were predicted by ANGPLY, the point of debonding was not accurately modeled at 427 °C using the combined stress criterion.

Figure 10.—Tensile curves for  $[\pm 45^\circ]_{2s}$ . Strain rate,  $10^{-4} \text{ sec}^{-1}$ .

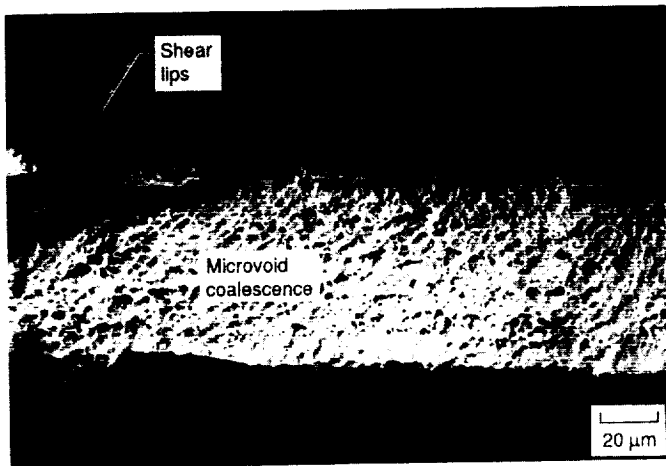
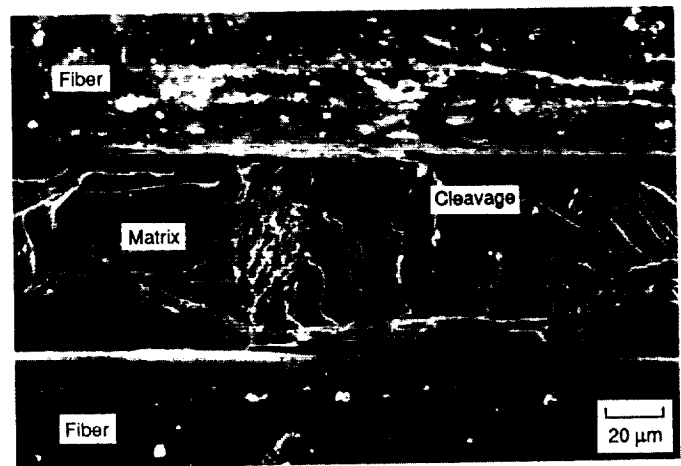
Figure 17.—Fractographs of  $[90^\circ]_8$  specimens.

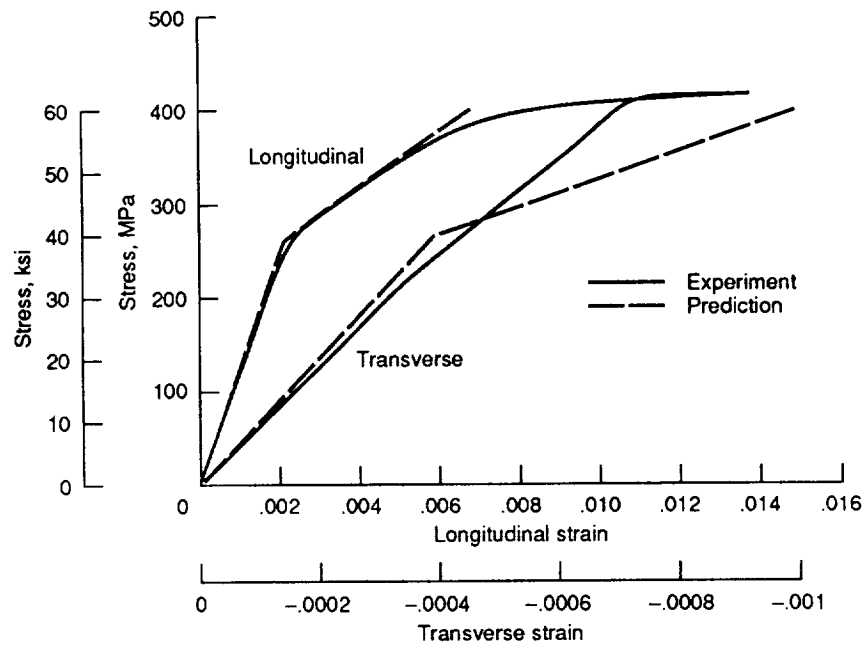
Predictions for the  $[90^\circ]_g$  data are shown in figure 41. The predicted and experimental data agreed in the elastic region in both the longitudinal and transverse directions. However, as the composite continued to strain, a break in the experimental stress-strain curve appeared and represents the point at which the modulus changes from  $E_I$  to  $E_g$ . This occurred at a laminate stress of  $\approx 275$  MPa. This initial break from linear elastic behavior has been identified by others (ref. 7), at least on the edge of the specimen, as being a result of interfacial debonding.

In the nonlinear portions of the stress-strain curve, AGLPLY failed to predict the stress-strain curve as illustrated in fig. 41. Continued loading in AGLPLY up to the failure stress showed no deviation from the linear  $E_s$  line for the longitudinal stress-strain case. This indicates that the stresses in the matrix were lower than the proportional limit. After straining to 1.0 percent (point B in fig. 7(b)), the only damage which can be observed was debonding (fig. 37). These results indicate that global plasticity in the matrix is unlikely. Similar to the  $[0^\circ]_8$  behavior, it is not known if debonding alone can account for all the nonlinearity in the curve.

Figure 41.—Room temperature tensile curves for  $[90^\circ]_8$  specimen.

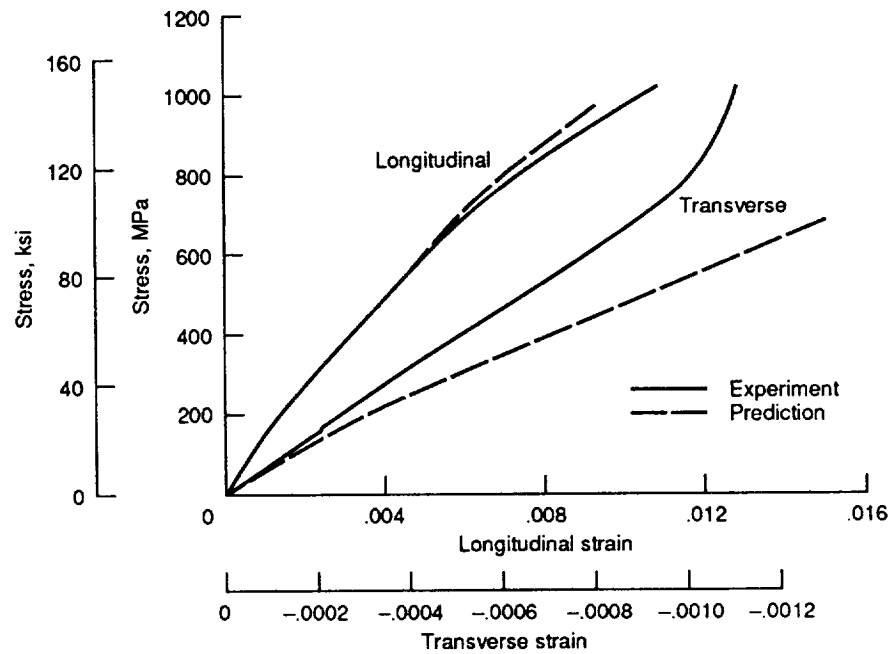
The AGLPLY predictions for the  $[0^\circ/90^\circ]_{2s}$  orientations are given in figure 42. Excellent agreement between experimental data and the calculations is observed in the longitudinal direction. For this orientation, a reduced fiber modulus only for the  $90^\circ$  plies was used when the radial or matrix stress in these plies reached 275 MPa. This occurred at an applied laminate stress of 180 MPa. The applied stress at which debonding occurs is lower than in the  $[90^\circ]_8$  specimens, and this is due to the effects of the  $0^\circ$  plies in the  $[0^\circ/90^\circ]_{2s}$  layup. The reduced fiber modulus provided excellent agreement with the break in the elastic line as well as in the longitudinal  $E_s$  value observed from the experiment. The predicted stress-transverse strain curve did not agree with the data except in the linear elastic region. Again, the predicted transverse  $E_s$  was lower than the actual value and could be a result of the directional nature of debonding.

debonding (excluding the main crack). At high strains the predicted response compares adequately with the data, as shown in figure 42. The prediction is better than that of the  $[90^\circ]_8$  orientation (fig. 41) and worse than that of the  $[0^\circ]_8$  orientation (fig. 40).

Figure 42.—Room temperature tensile curves for  $[0^\circ/90^\circ]_{2s}$  specimen.

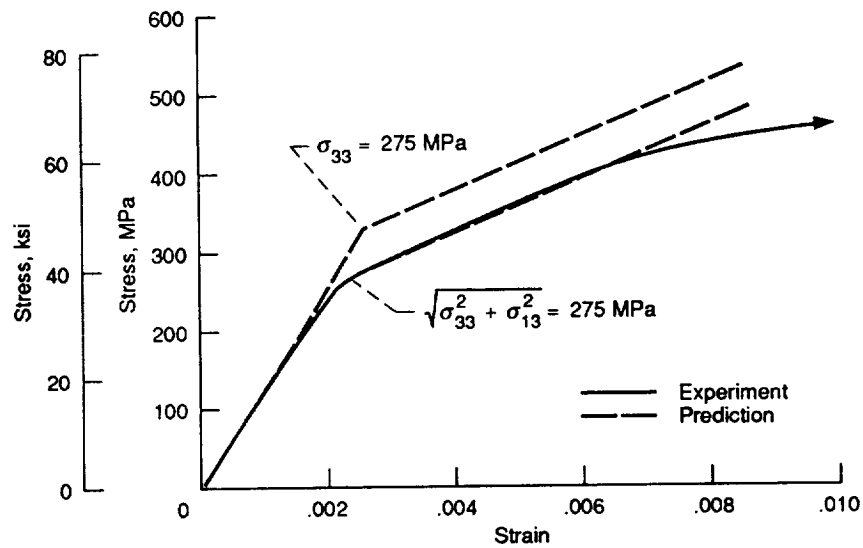
The  $[\pm 45^\circ]_{2s}$  layup has a unique stress-strain response in that the failure strains are significantly larger than any of the other layups ( $\approx 7$  percent compared with  $\approx 1$  percent). Prediction of the  $[\pm 45^\circ]_{2s}$  stress-strain curve is shown in figure 43. There is good agreement between the predicted and experimental laminate stress and longitudinal strain in the linear elastic region. However, the predicted laminate stress at which debonding occurs is too high. Examination of the calculated matrix stresses at the point of actual debonding (250 MPa) indicates that the matrix stresses,  $\sigma_{33}$  and  $\sigma_{13}$  are 240 and 124 MPa, respectively. Since  $\sigma_{13}$  is a large percentage of  $\sigma_{33}$ , it was assumed that the shear stress would also play a role in the debonding process. Therefore, an arbitrary effective stress criterion for debonding was used in which  $(\sigma_{33}^2 + \sigma_{13}^2)^{1/2} = 275$  MPa. Attainment of this criterion for the  $[\pm 45^\circ]_{2s}$  specimen occurred at a predicted applied stress of 250 MPa, which agrees with the actual break in the stress-strain curve. After debonding occurred, the reduced effective fiber modulus of 13 GPa (the same value used for the  $[90^\circ]_8$  experiment) was used to calculate a value for  $E_s$  of 34 GPa, which was identical to the experimental value (table I). Again, AGLPLY cannot predict the remainder of the stress-strain curve. This is probably due to the extensive fiber cracking (fig. 33) observed at larger strains. Matrix cracking could also play a role in the nonlinear behavior.

Figure 43.—Room temperature tensile curve for  $[\pm 45^\circ]_{2s}$  specimen.

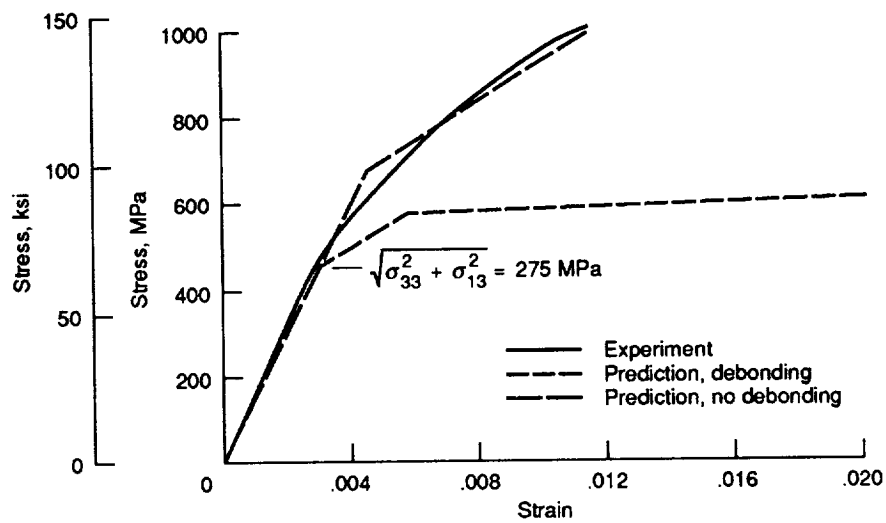
The behavior of the  $[\pm 30^\circ]_{2s}$  orientation can not be predicted using AGLPLY (as seen from figure 44). Although the linear elastic line can be accurately predicted, the rest of the stress-strain curve cannot. Using the combined stress criterion to predict debonding, the first point of nonlinearity can be adequately modeled. However, the predicted  $E_s$  slope is much lower than the experimental value. AGLPLY also predicts matrix yielding at an applied stress of 570 MPa, causing a gross overestimation of the laminate strain. A closer prediction is obtained by assuming that no debonding occurs, although the details of the experimental data are not captured, and it is clear that debonding does occur (fig. 39). The nonlinearity at high strains could be a result of local plasticity as a consequence of debonding as observed by the necking of the matrix in figure 39. Global plasticity, surface cracks from the leach pits (fig. 29), or a combination of these mechanisms could also contribute to the nonlinearity. It is unlikely that fiber cracking contributed to the nonlinearity since few fiber cracks were observed at strains less than 1 percent.

Figure 44.—Room temperature tensile curve for  $[\pm 30^\circ]_{2s}$  specimen.
